Our File: 2059

2014 October 24

Re: Old Trail Bridge

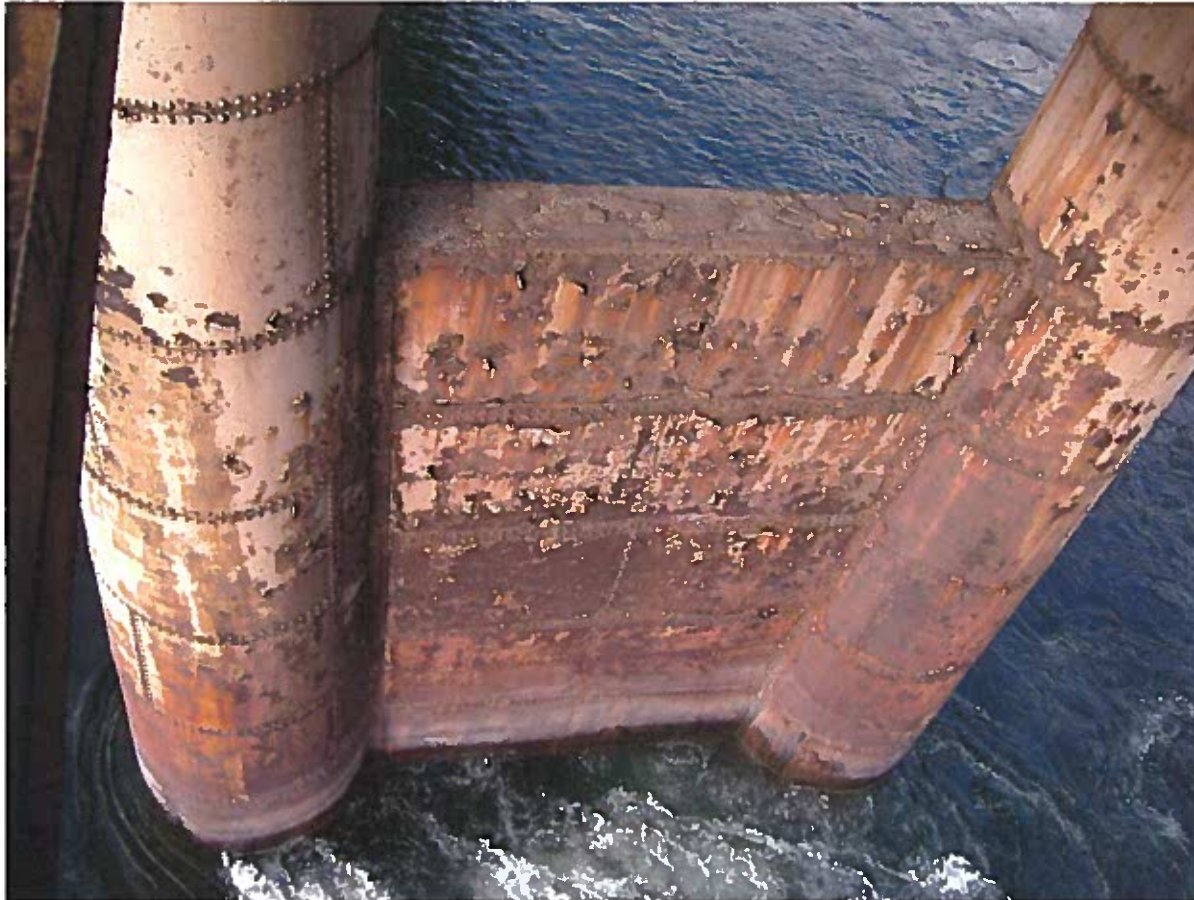
Photos 1 through 7 (attached) show the level of pier deterioration we observed during our 2010 Fall inspection. This level of deterioration requires complete replacement of the piers. For any bridge, replacement of piers without replacing its superstructure is difficult and costly.

**Photo 1: Typical Steel Shell Deterioration at Pier (corrosion is so extensive that the frame behavior of the piers is doubtful)**

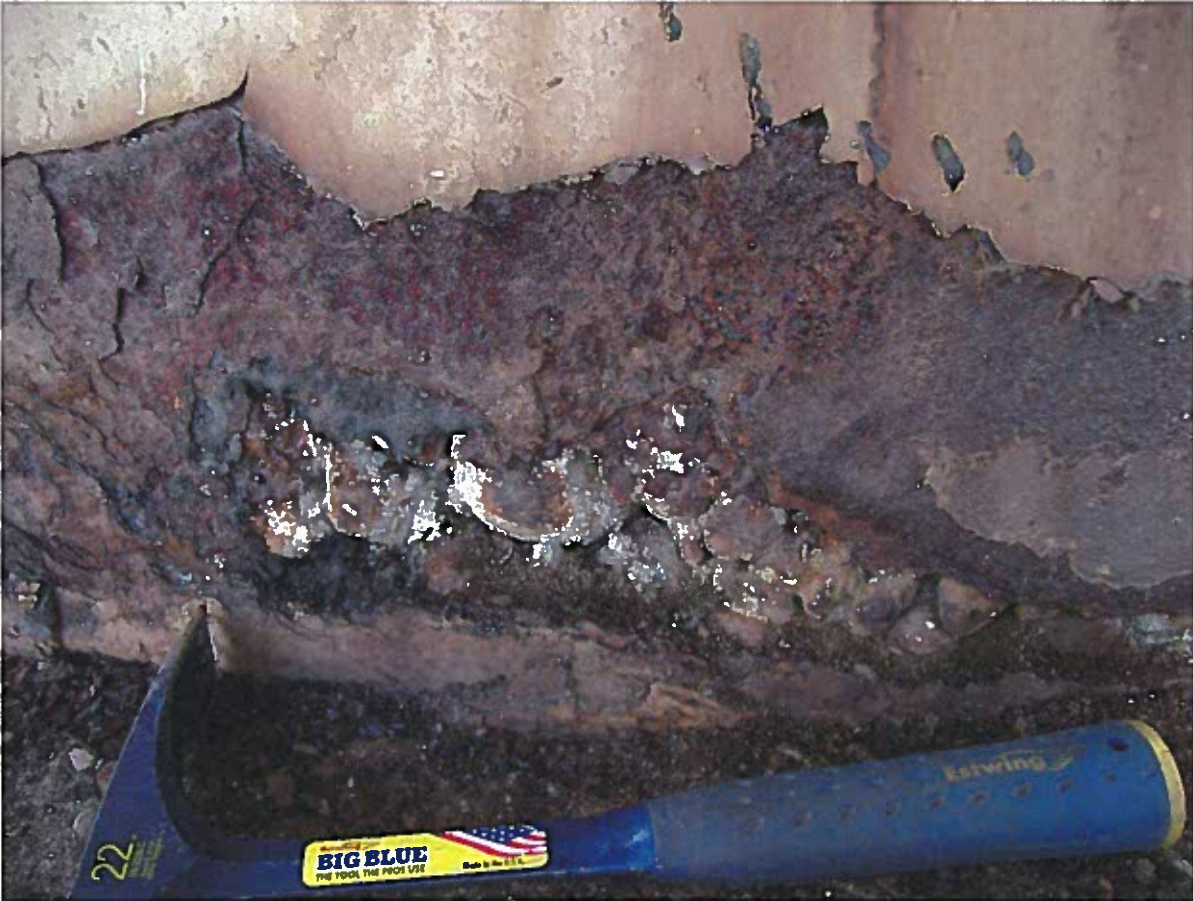
Photo 2: Close-up photo at Pier Cross Beam / Pipe Pier Interface showing loss of steel section and rubble (instead of concretes) within pier legs

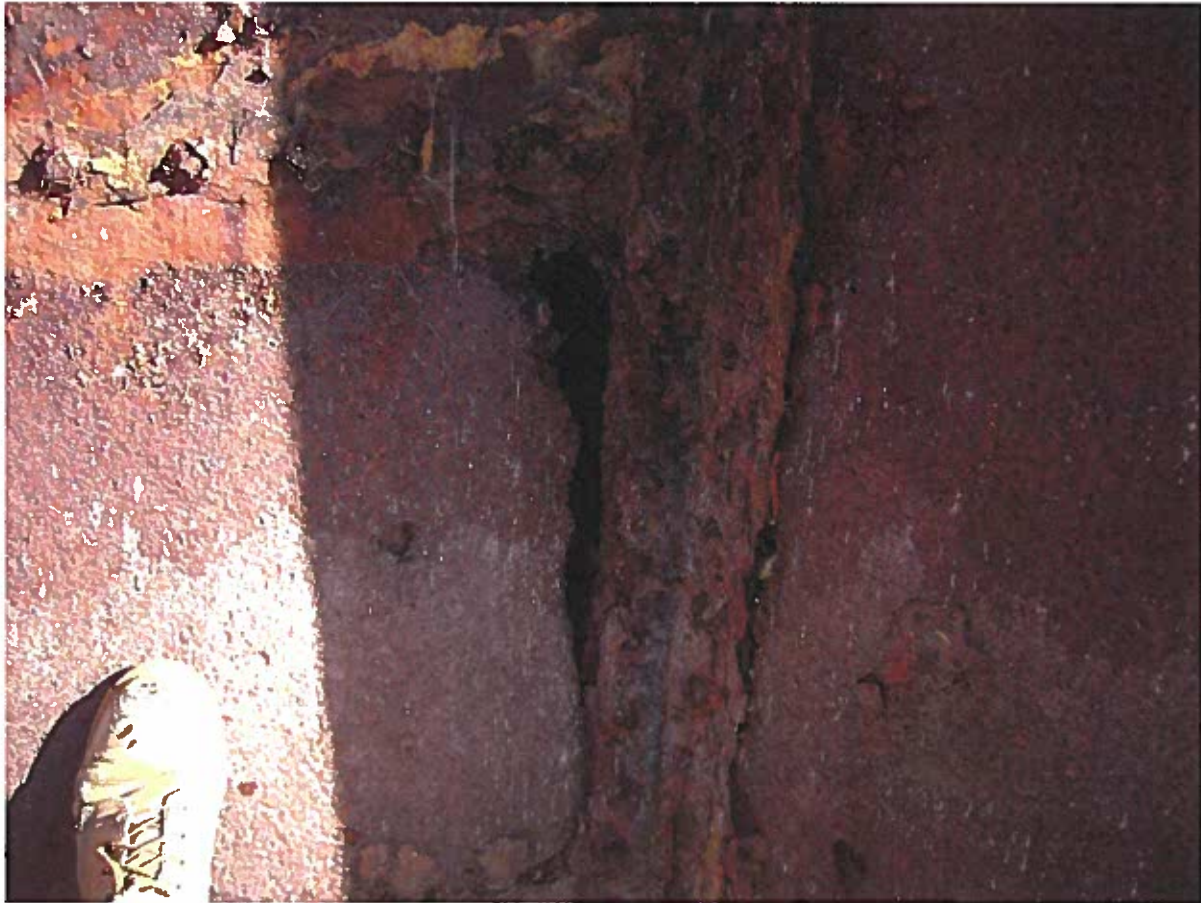
**Photo 3:** Close up photo at pier cross beam showing loss of concrete structural integrity within steel casing (steel casing can be pushed inwards) and heavy corrosion of the steel shell

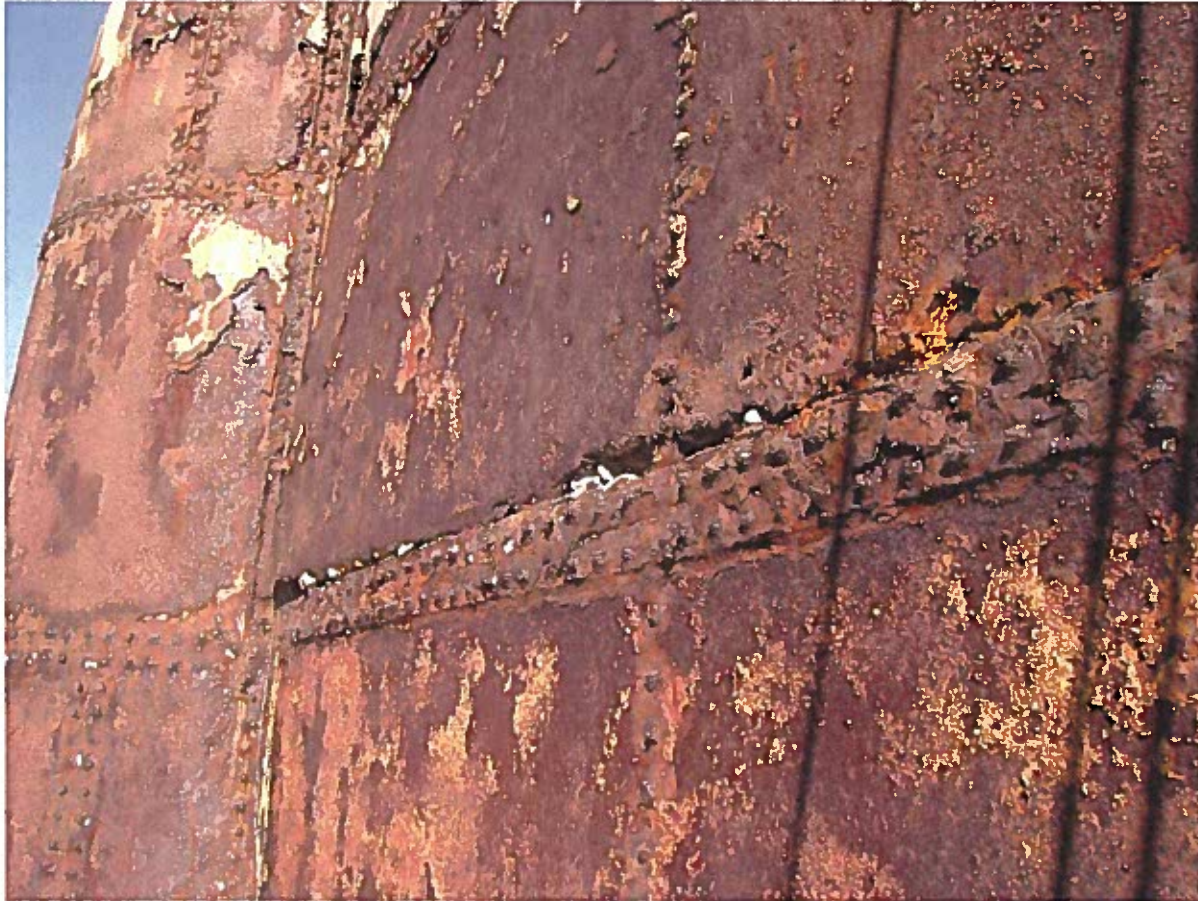
**Photo 4:** Close up photo at pier cross beam – heavy deterioration of steel shell

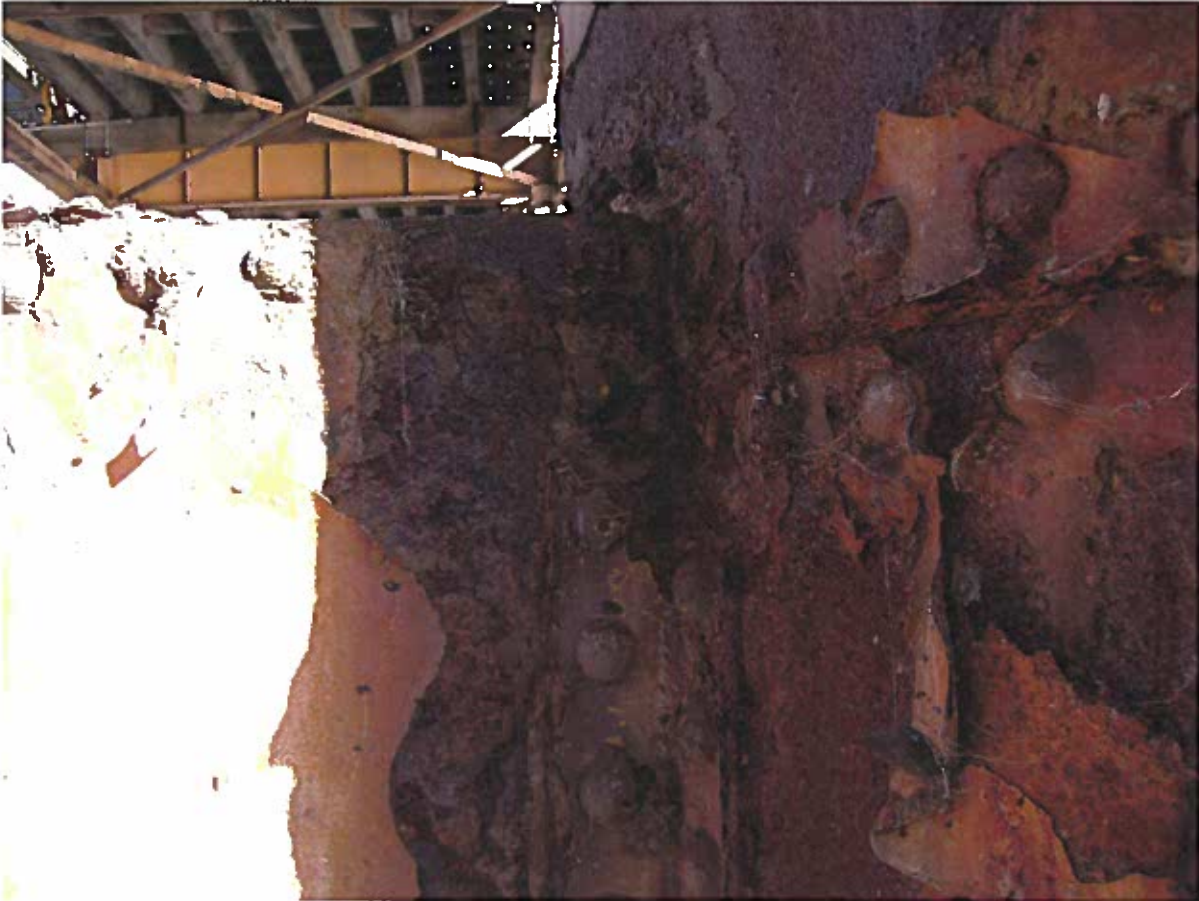
**Photo 5:** Close-up photo at Pier Cross Beam / Pipe Pier Interface showing loss of steel section and concrete rubble within pipe (heavy deterioration)

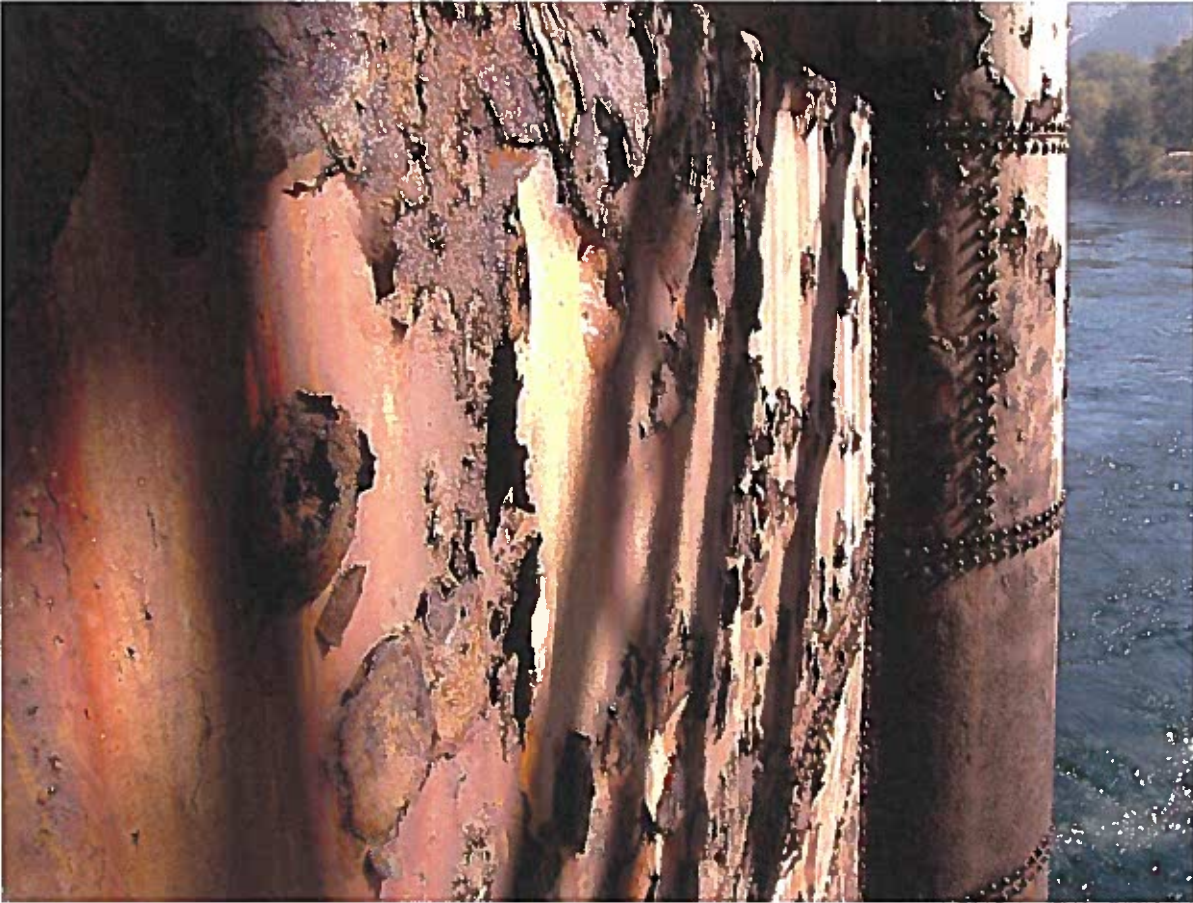
**Photo 6:** Close up photo at pier cross beam – heavy deterioration of steel shell

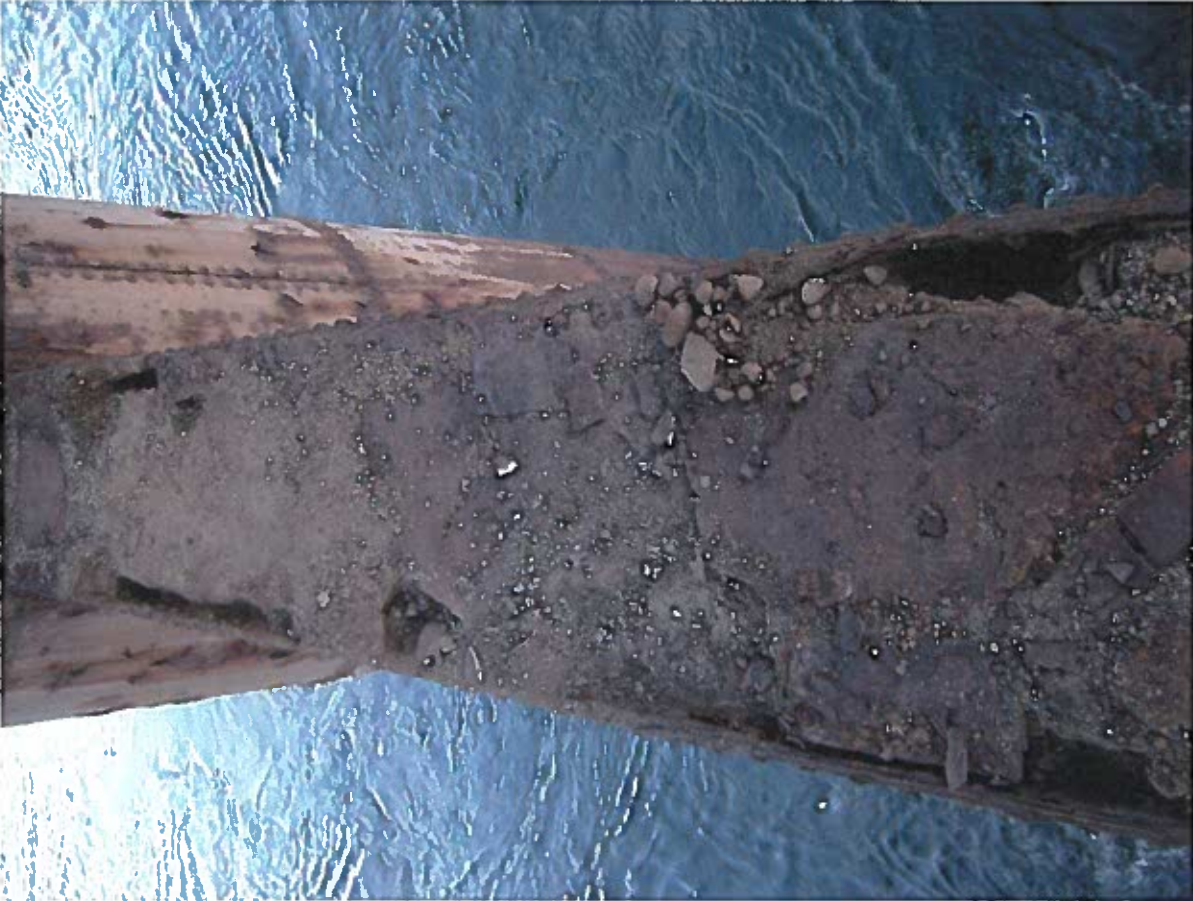
**Photo 7:** Pier Cross beam showing loss of concrete structure integrity within steel shell

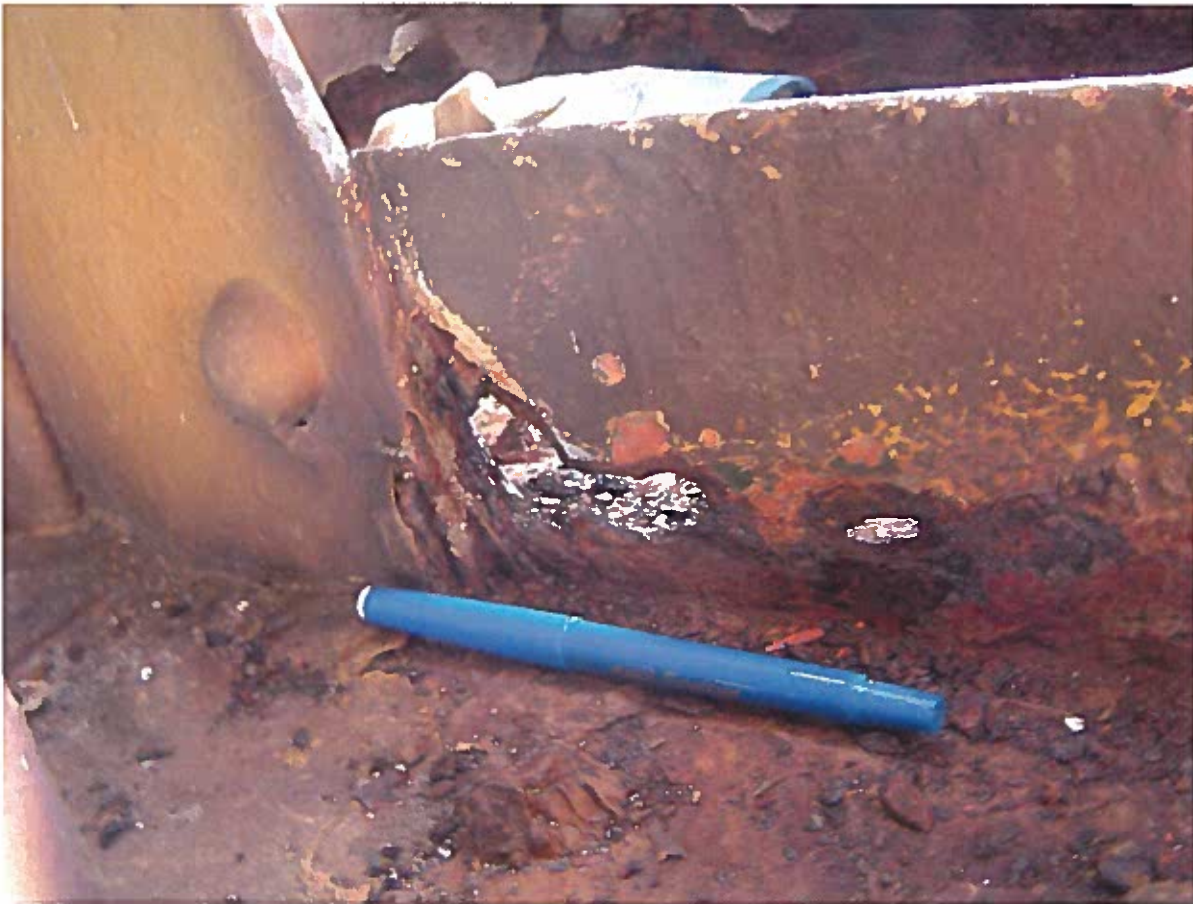
Photos 8 through 12 (attached) show the level of truss deterioration we observed during our 2010 Fall inspection. Given that the trusses are now over 100 years old, the remaining economic life of the superstructure is also limited, and rehabilitating them is costly.

**Photo 8: Loss of section in steel superstructure members**

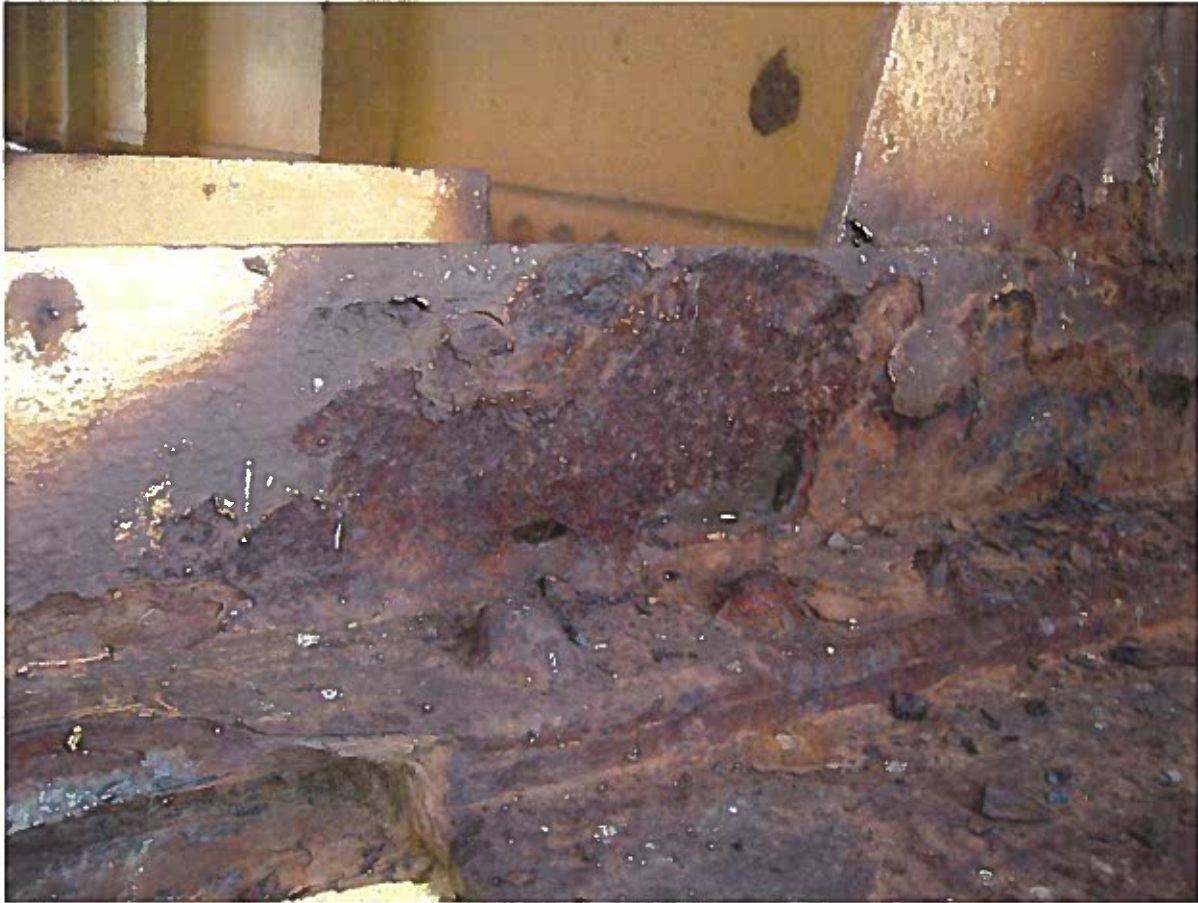
**Photo 9:** Loss of section in steel superstructure members

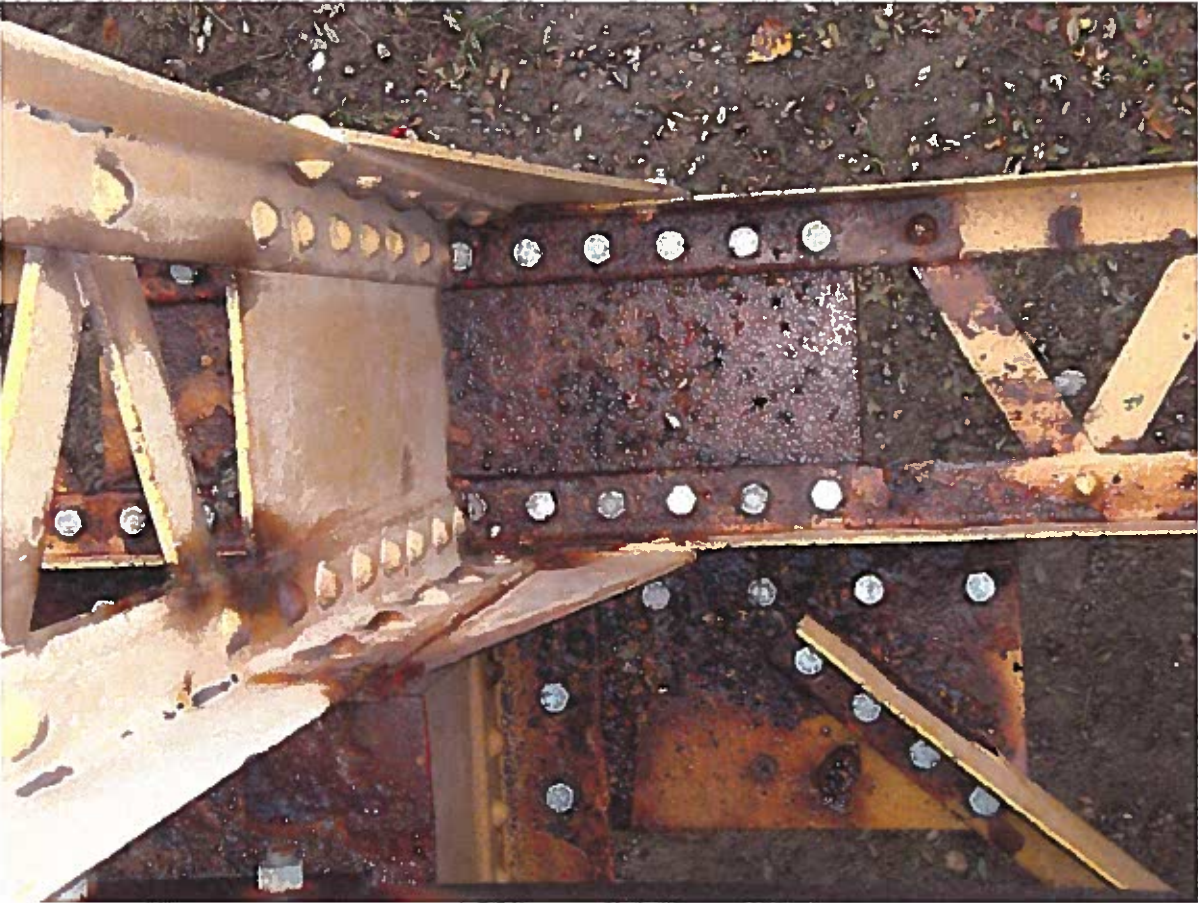
**Photo 10: Severe corrosion in steel superstructure connections**

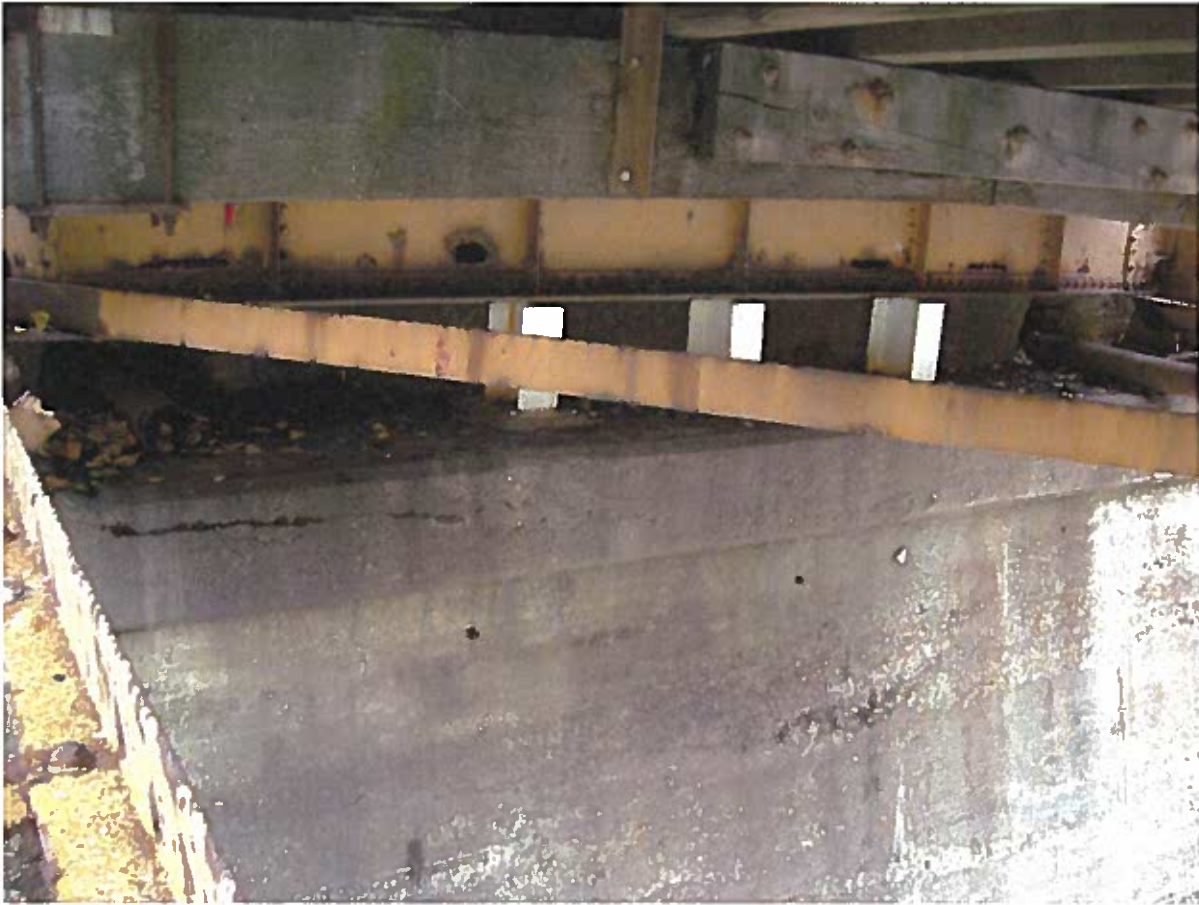
**Photo 11:** Loss of section in steel superstructure members

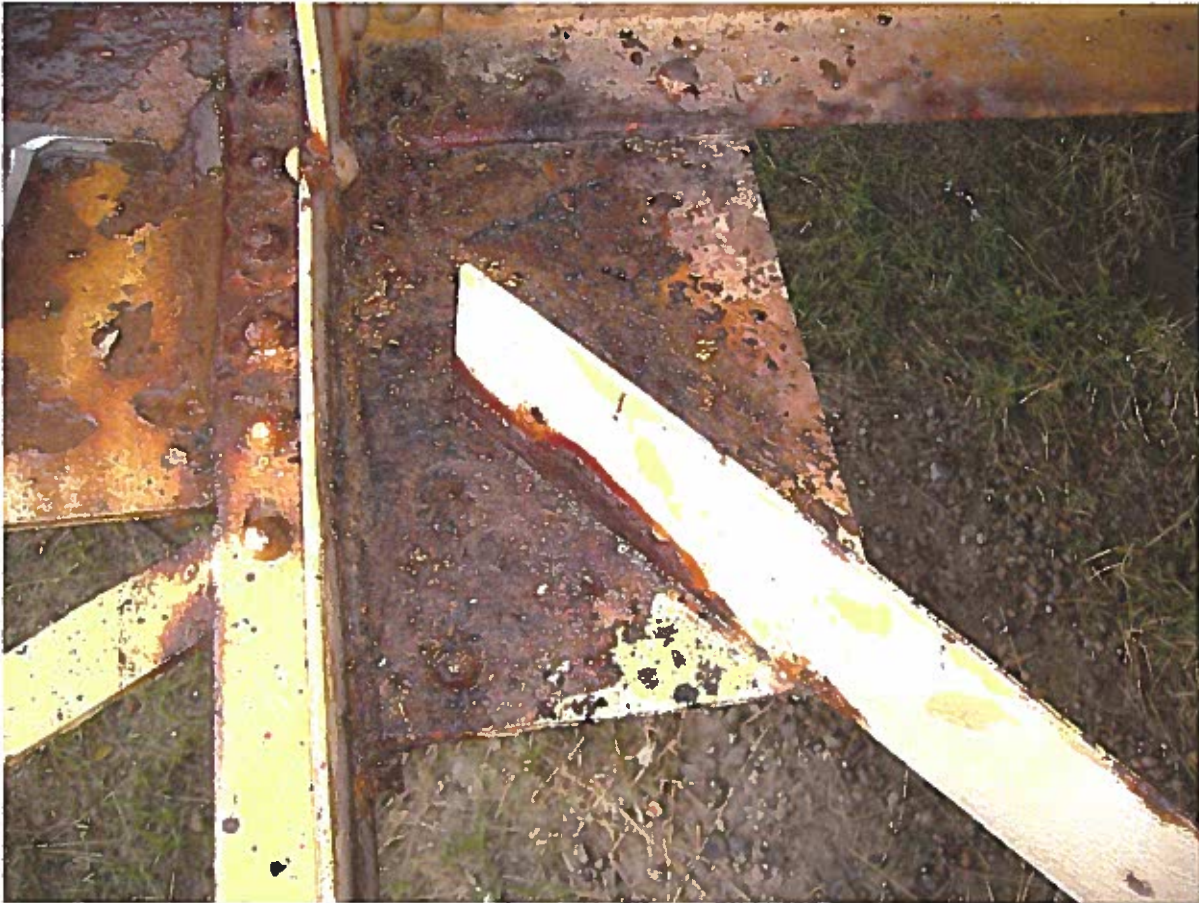
**Photo 12: Severe corrosion in steel superstructure riveted connections**
