## Investigation Summary Report

| Client: | WSA Engineering | Date : | February 04 2026 |
| Phone: | | Site Address: | Lot 367 Tadanac Trail BC |

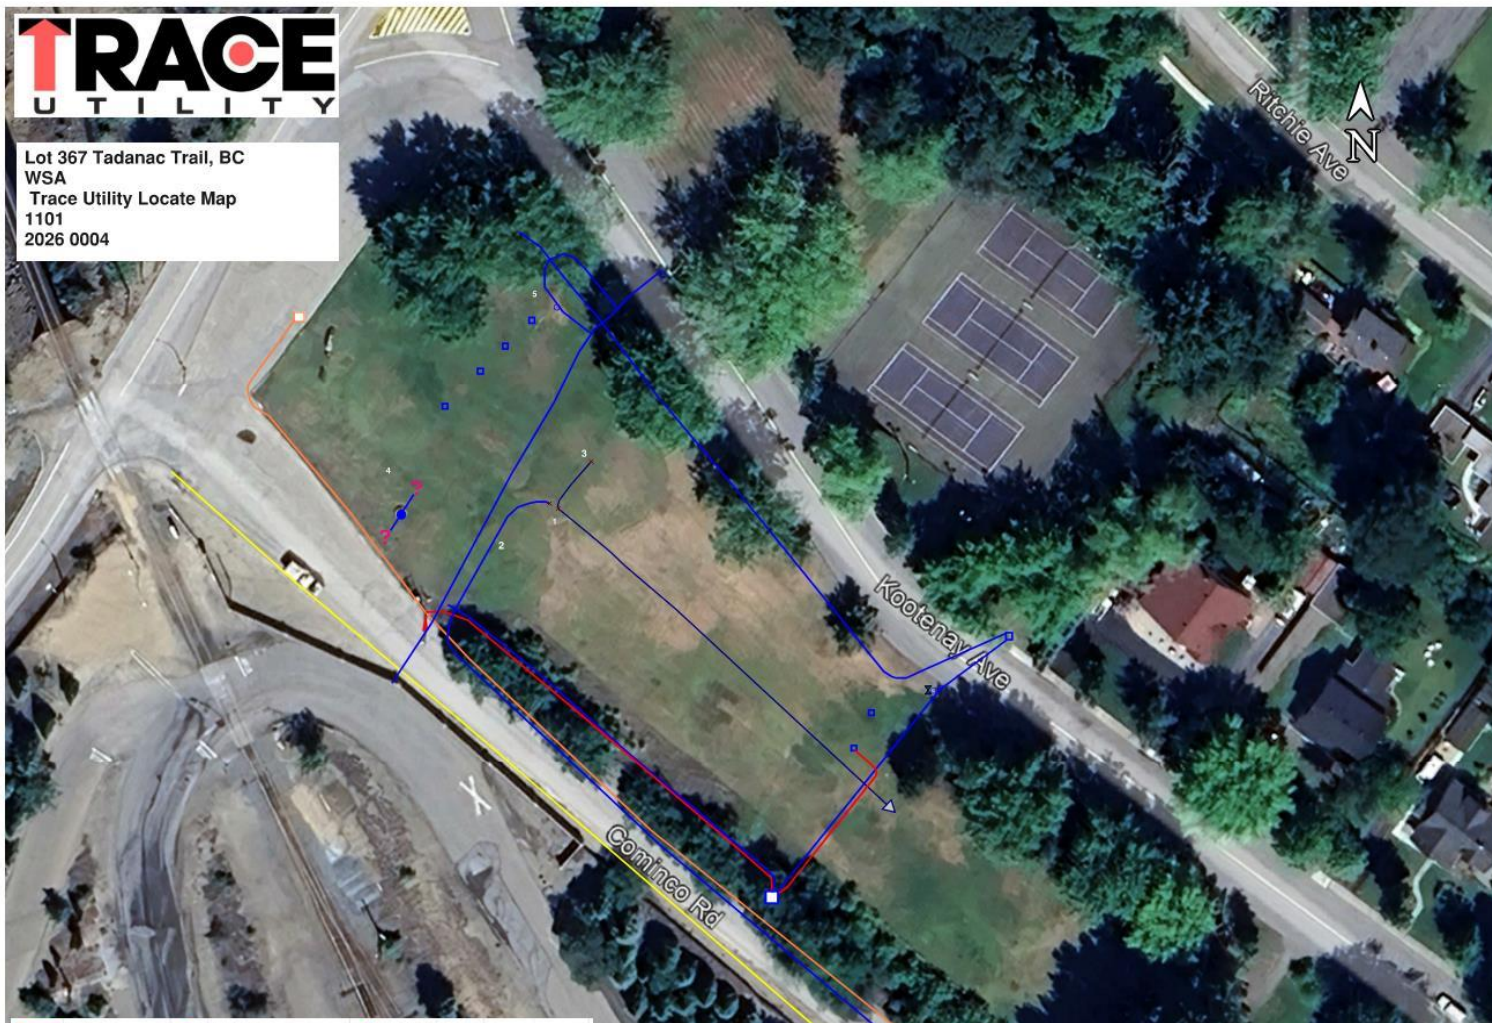
### See Map :

- 1 Induced Signal Lost along expected path of 100 Cast line .
- 2 Signal detected while searching for Line 1 Expect this to be 400 SP Pipe. Signal likely transfers to larger conductive material and explains why signal is lost from Line 1

3. Signal Lost after turn on 100 Cast Pipe. Pipe could be driving deeper. Or affected by larger conductive material on 150 cast pipe as it intersects this utility

4. pipe is visible from manhole. ~ 3m down. Pipe appears to be PVC and not locatable using traditional EM locate methods. Outside Work scope. No time was used to determine path

- 5 . Plans and schematics indicate ties to infrastructure. None of these exist on the ground, Unable to direct connect locate tools to lines. When inducing signal all conductive material are energized making precise location difficult. Over lapping pipes and unknow directions could increase error. Area outside Project Scope. Minimal time wa used to search for how this fits together with out direct connections to individual lines.

WorkSafe BC best practice “The hand expose zone is a distance 1m either side of the utility marks within which excavation and mechanical equipment must not take place” Trace Utility’s recommendation is to stay 2 meters from all markings if utility will not be exposed.
