APPENDIX E - SITE MAPPING

High Risk Tree Removal  
and Maintenance

City of Trail - RFP # 2026-8550-5300

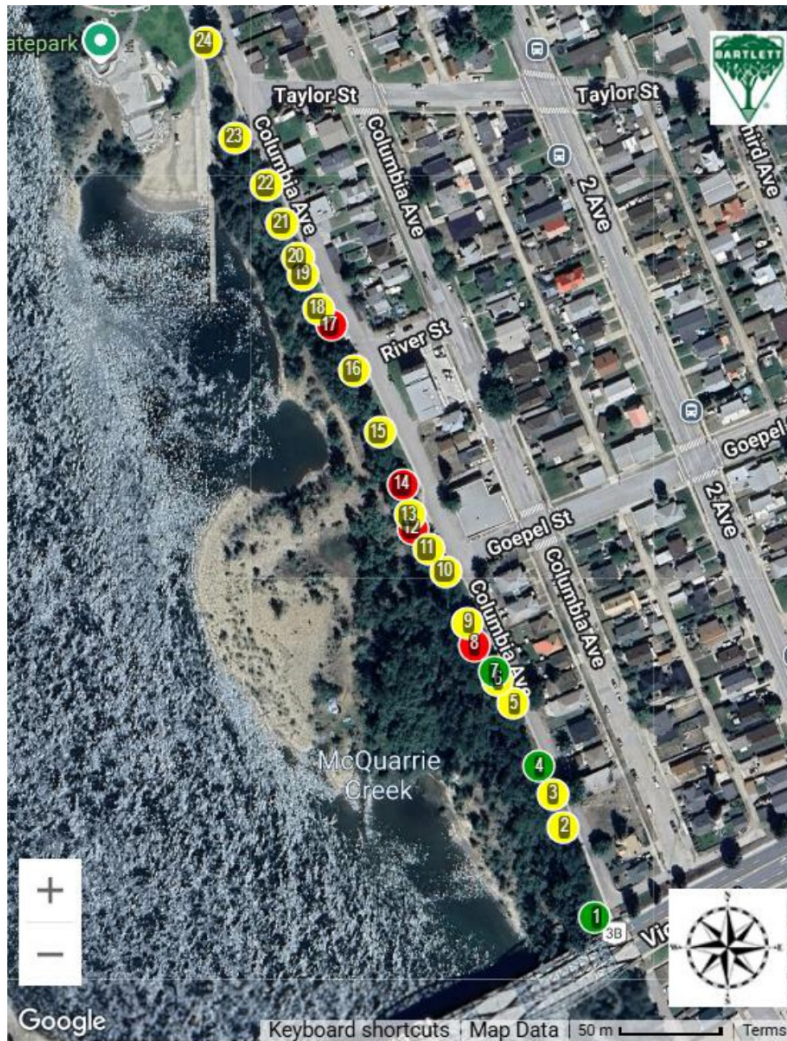
Dyke Road  
INVENTORIED TREES BY CONDITION CLASS

| ID | Action | Species / DBH | Risk | Target | Notes |
|---|---|---|---|---|---|
| 14 | REMOVE | Poplar-Balsam<br>DBH: 43,32 cm | Moderate<br>Poor | Path | Decay in stem. |
| 16 | PRUNE | Poplar-Balsam<br>DBH: 53 cm | Moderate<br>Fair | Path | Risk-mitigation pruning; dead branches, moderate dieback and overextended branch. |

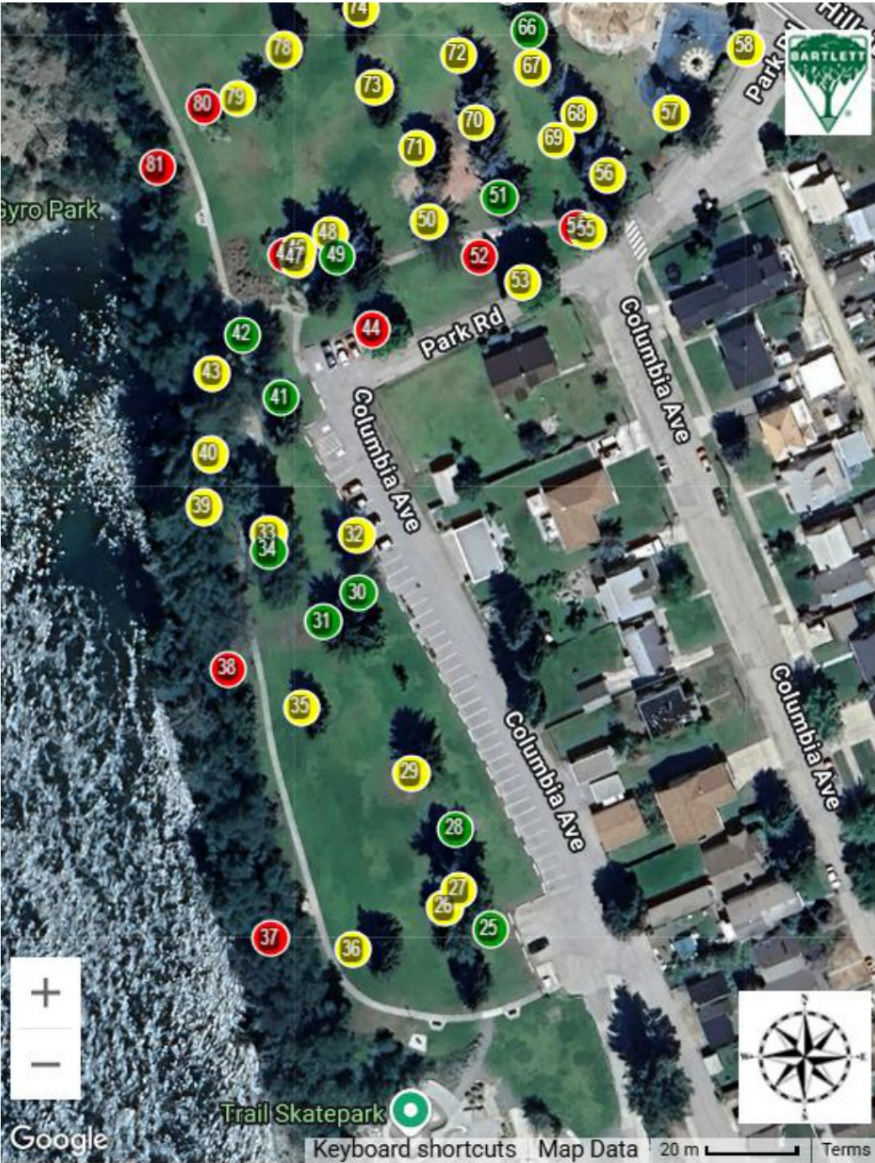
Gyro Park (south)  
INVENTORIED TREES BY CONDITION CLASS

| ID | Action | Species / DBH | Risk | Target | Notes |
|---|---|---|---|---|---|
| 27 | PRUNE | Poplar-Balsam<br>DBH: 102 cm | Low<br>Fair | Path | Level 3 stem assessment and risk-mitigation pruning; co-dominant stems, dead branches and included bark. |

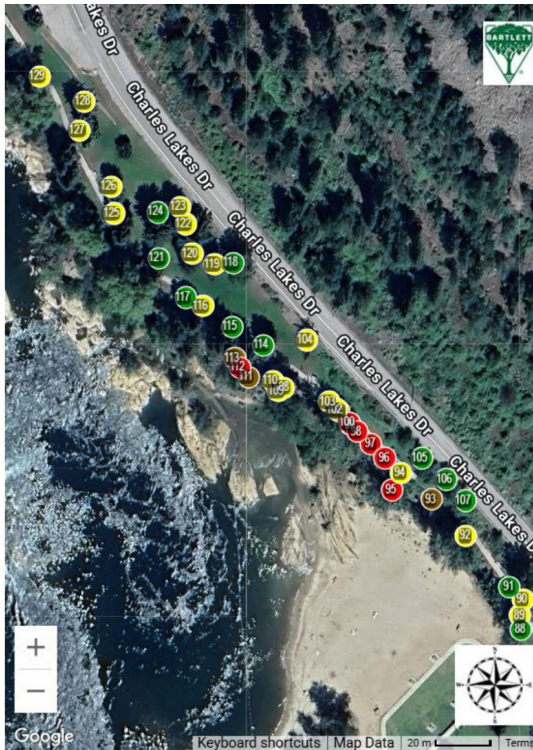
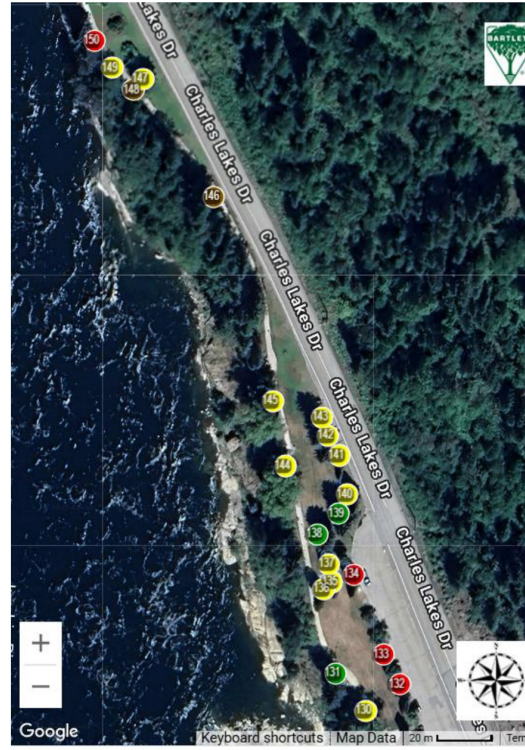
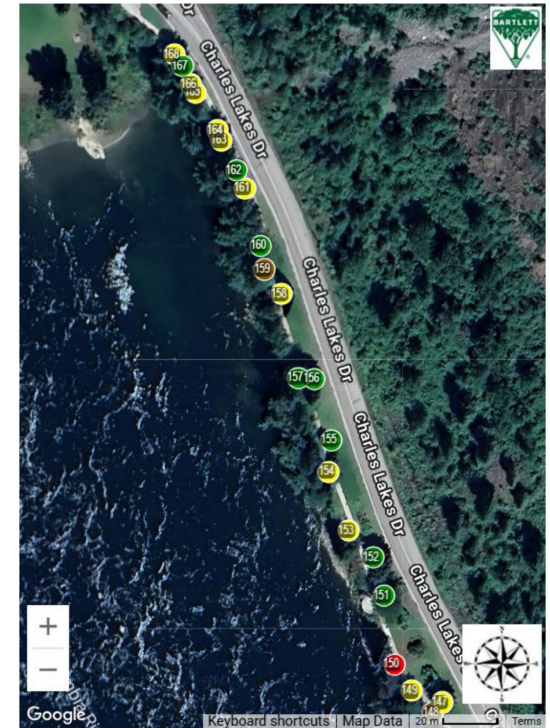
| ID | Action | Species / DBH | Risk | Target | Notes |
|---|---|---|---|---|---|
| 104 | PRUNE | Sweet Birch<br>DBH: 34 cm | Moderate<br>Fair | Street | Risk-mitigation and clearance pruning; dead branches and prior topping/heading cuts. |
| 129 | PRUNE | Weeping Willow<br>DBH: 145 cm | Low<br>Fair | Path | Risk-mitigation pruning and branch-end weight reduction; cavity and dead branches. |

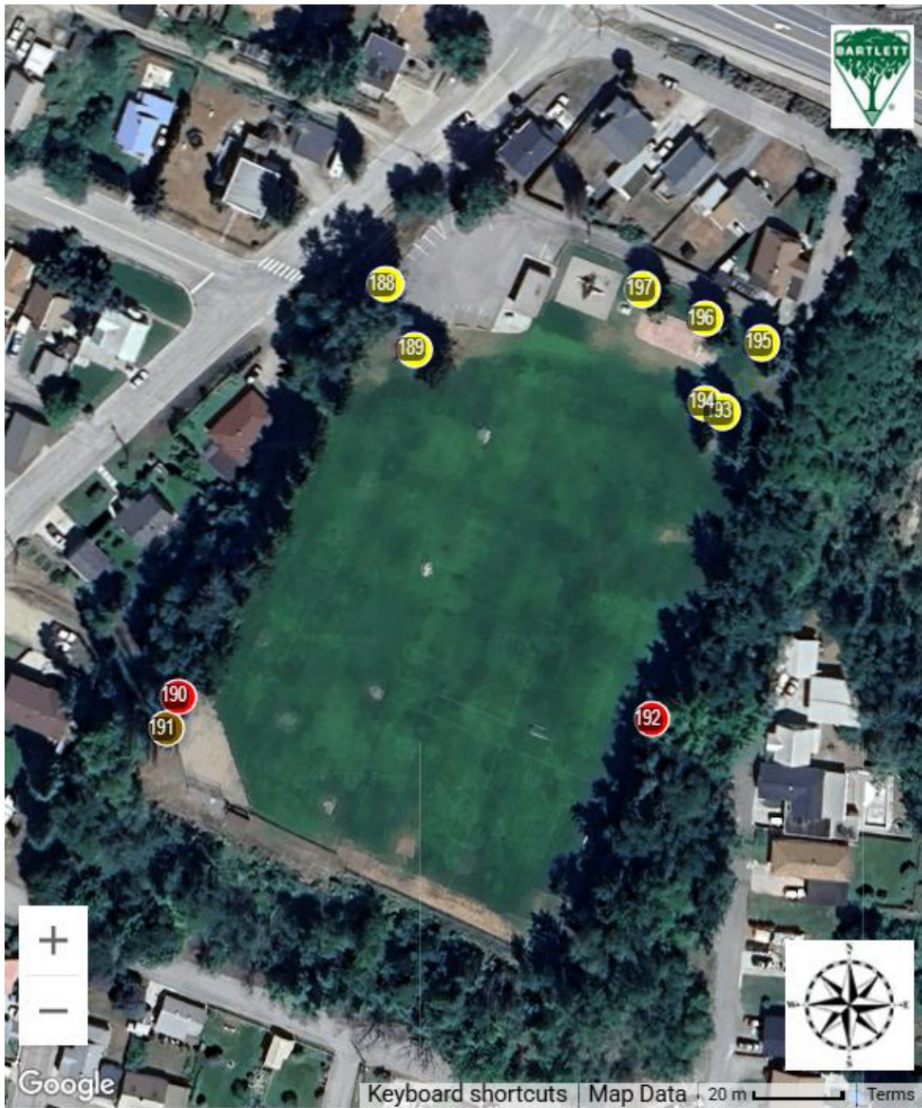
Pople Park  
INVENTORIED TREES BY CONDITION CLASS

| ID | Action | Species / DBH | Risk | Target | Notes |
|---|---|---|---|---|---|
| 192 | REMOVE | Siberian Elm<br>DBH: 54 cm | Moderate<br>Poor | Play area | Cavity at root flare, stem crack and poor structure. |

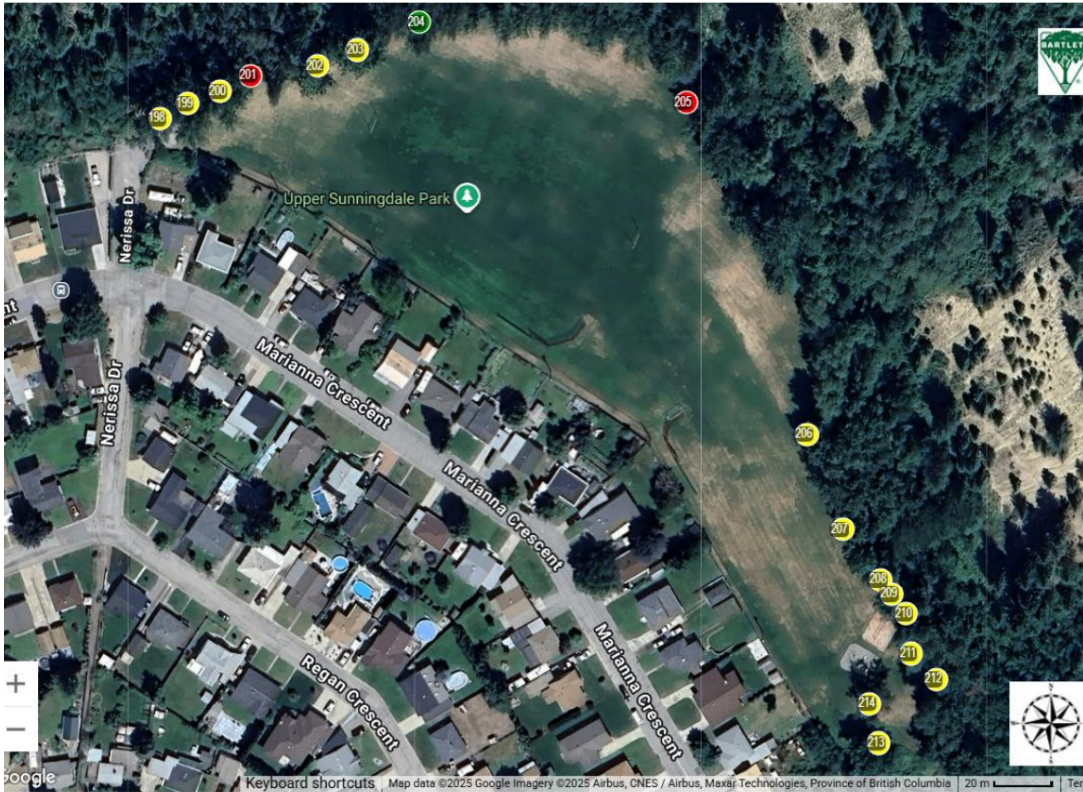
Upper Sunningdale Park  
INVENTORIED TREES BY CONDITION CLASS

| ID | Action | Species / DBH | Risk | Target | Notes |
|---|---|---|---|---|---|
| 201 | REMOVE | Poplar-Balsam<br>DBH: 36 cm | Moderate<br>Poor | Bench | Stem crack. |

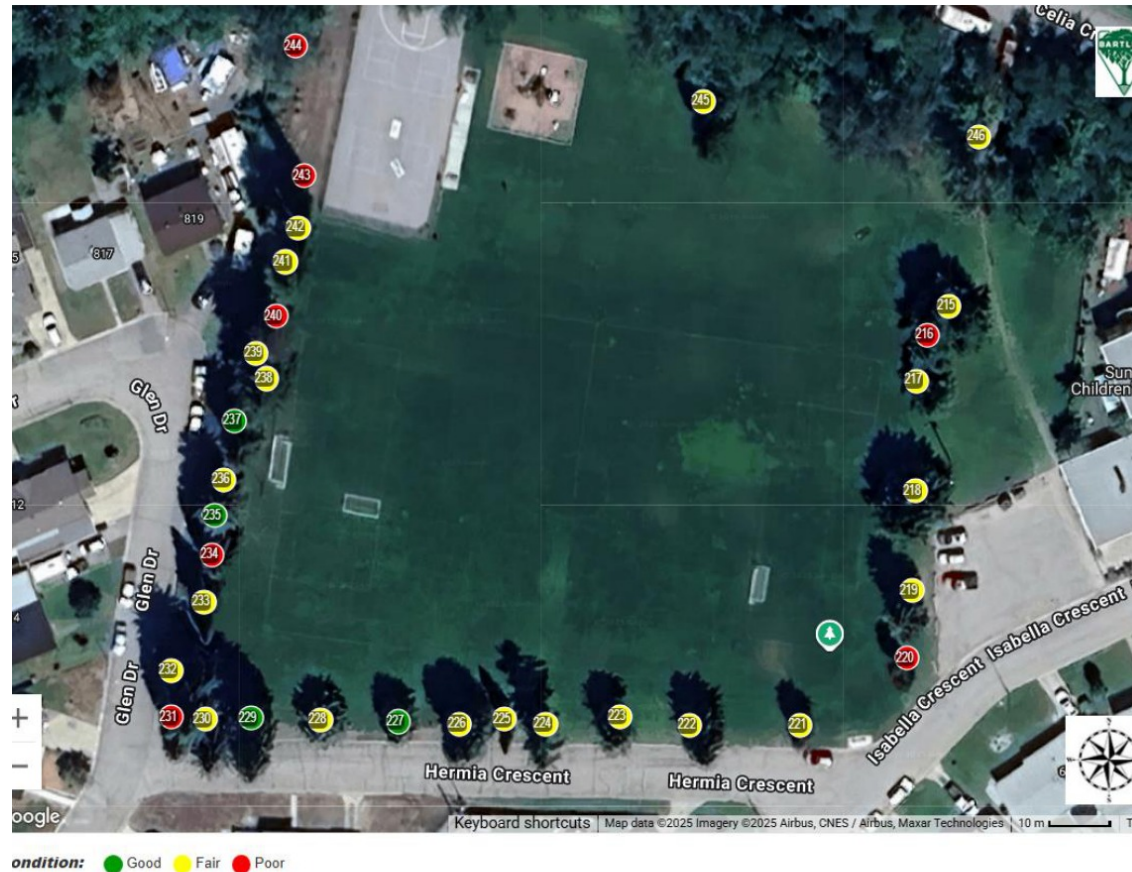
## Lower Sunningdale Park INVENTORIED TREES BY CONDITION CLASS

| ID | Action | Species / DBH | Risk | Target | Notes |
|---|---|---|---|---|---|
| 243 | REMOVE | Subalpine Fir<br>DBH: 54 cm | Moderate<br>Poor | Building | Stem decay, fungi/conks and hollow sound. |
| 244 | REMOVE | White Poplar<br>DBH: 52 cm | High<br>Poor | Play area | Root-flare cavity/decay and partial stem failure. |
| 246 | PRUNE | Narrowleaf Poplar<br>DBH: 99 cm | Moderate<br>Fair | Path | Risk-mitigation pruning and crown reduction; dead branches. |

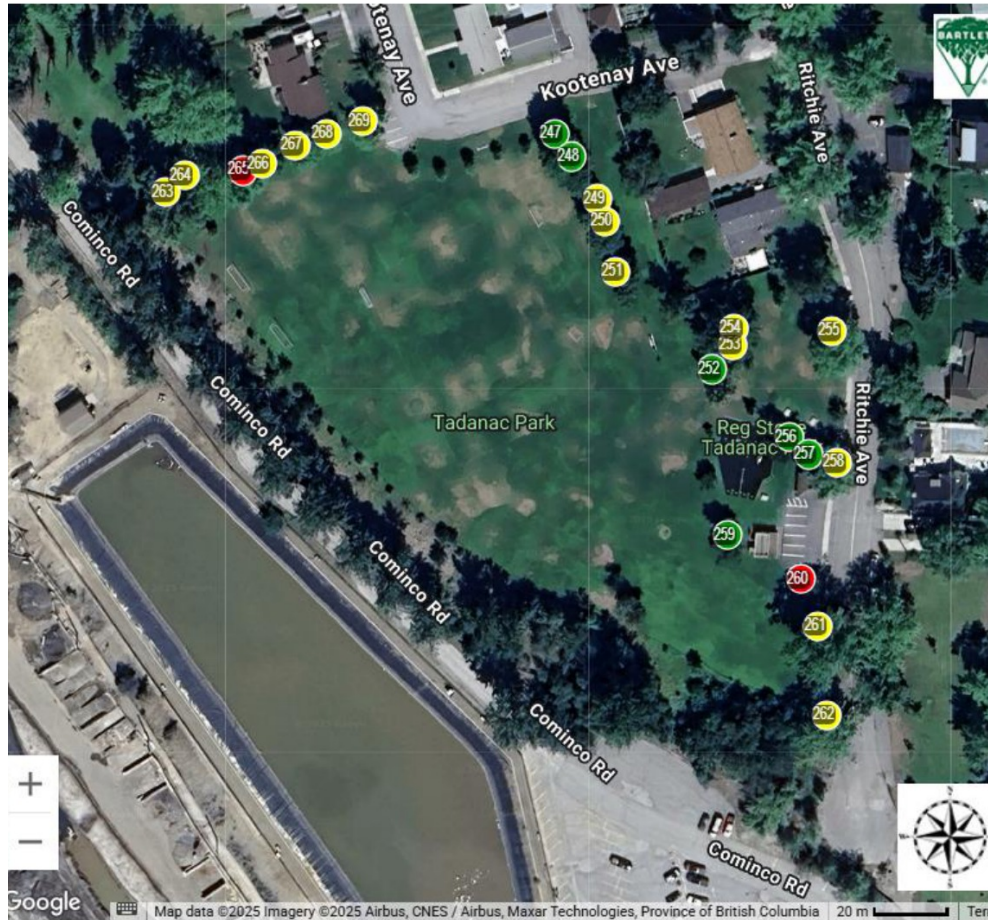
Reg Stone Park  
INVENTORIED TREES BY CONDITION CLASS

| ID | Action | Species / DBH | Risk | Target | Notes |
|---|---|---|---|---|---|
| 255 | PRUNE | Silver Maple<br>DBH: 97 cm | Low<br>Fair | Street | Level 3 crown/stem assessment plus risk-mitigation and crown-reduction pruning. |
| 261 | PRUNE | Silver Maple<br>DBH: 103 cm | Low<br>Fair | Street | Risk-mitigation pruning and size maintenance; broken branch, dead branches and hanger. |
| 263 | MONITOR | Narrowleaf Poplar<br>DBH: 122 cm | Moderate<br>Fair | Play area | Retain/monitor pending City direction; source recommendation also identifies Level 3 assessment/pruning or removal. Tree sounds hollow. |

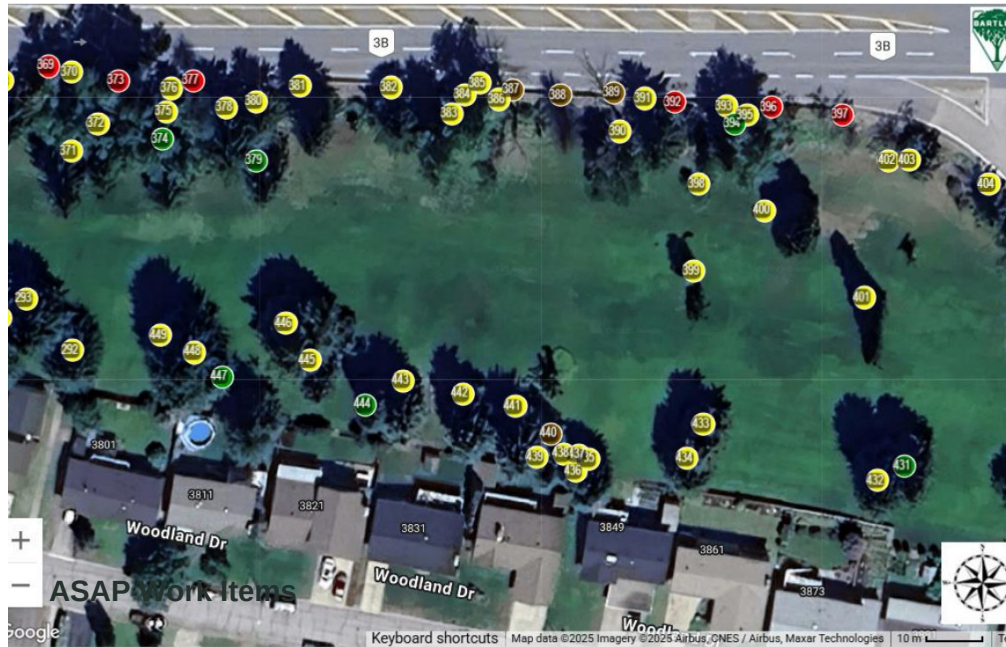
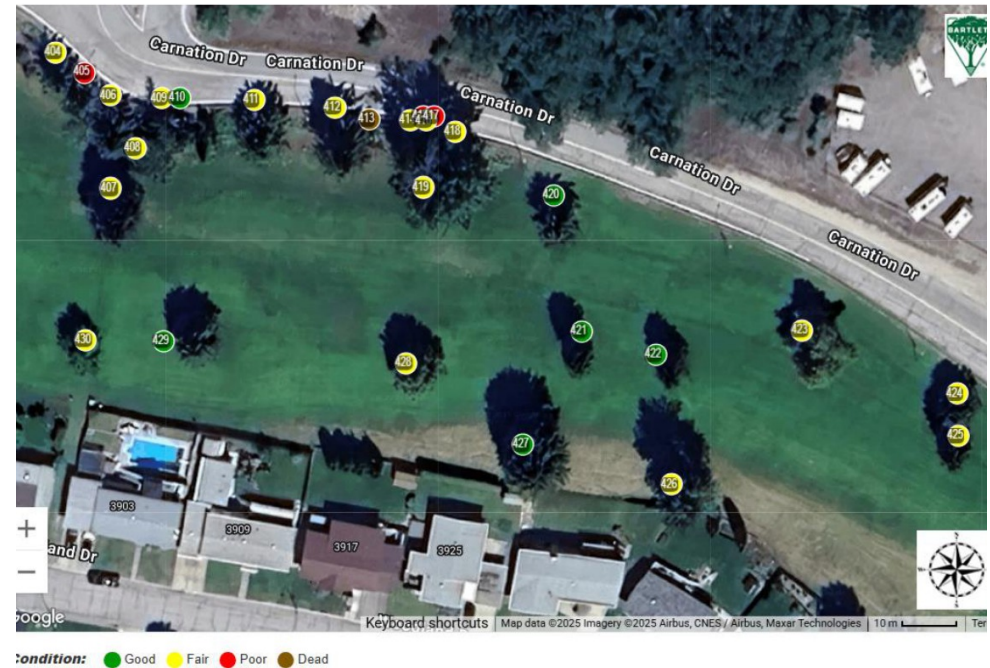
| ID | Action | Species / DBH | Risk | Target | Notes |
|---|---|---|---|---|---|
| 369 | REMOVE | Poplar-Balsam<br>DBH: 46,42 cm | Moderate<br>Poor | Street | Co-dominant stems and stem decay. |
| 373 | REMOVE | Poplar-Balsam<br>DBH: 60,60,52 cm | Moderate<br>Poor | Street | Broken branch, co-dominant stems, crack at union/stem and stem wound. |
| 377 | REMOVE | Trembling Aspen<br>DBH: 24,22 cm | Moderate<br>Poor | Street | Stem cavity/decay, dead or dying stem and moderate dieback. |
| 387 | REMOVE | Poplar-Balsam<br>DBH: 72 cm | Moderate<br>Dead | Street | Dead tree. |
| 388 | REMOVE | Norway Spruce<br>DBH: 56 cm | Low<br>Dead | Street | Dead tree. |
| 389 | REMOVE | Poplar-Balsam<br>DBH: 60 cm | Moderate<br>Dead | Street | Dead tree. |

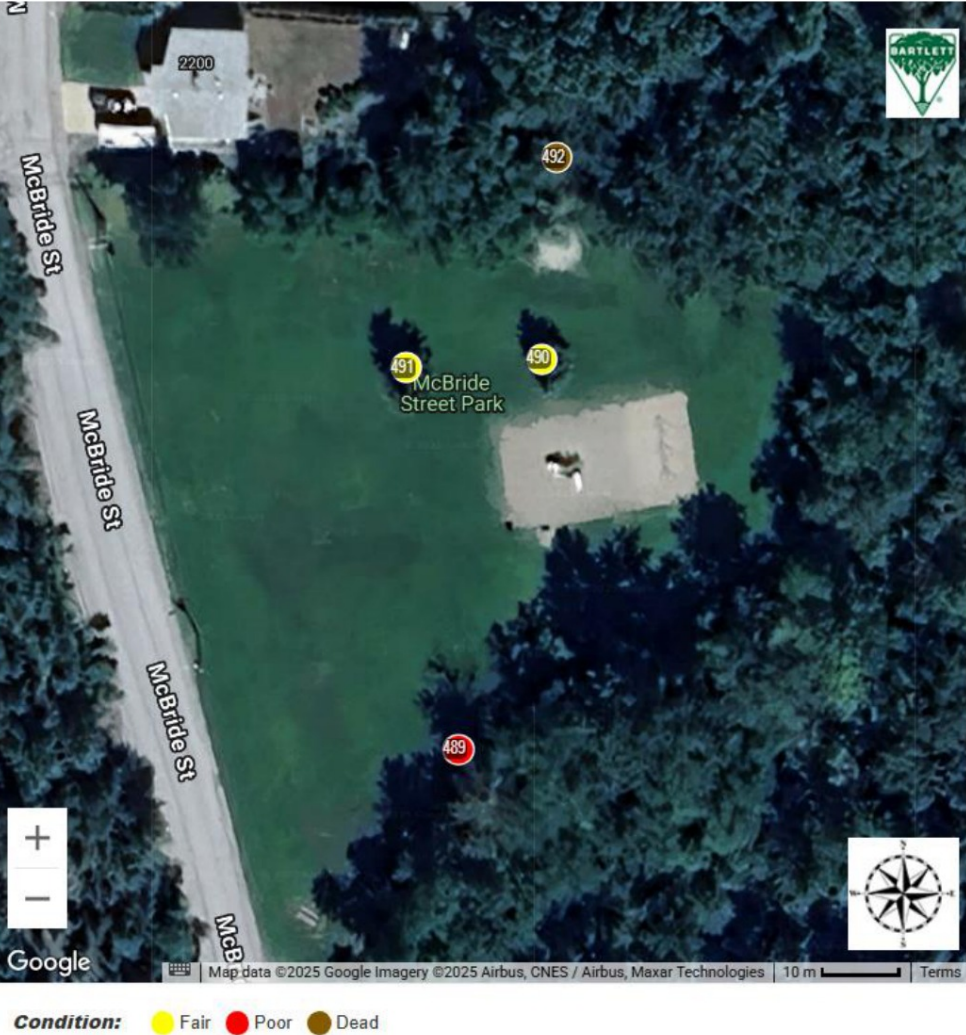
## McBride Street Park INVENTORIED TREES BY CONDITION CLASS

| ID | Action | Species / DBH | Risk | Target | Notes |
|---|---|---|---|---|---|
| 489 | REMOVE | Poplar-Balsam<br>DBH: 63 cm | Low<br>Poor | Path | Dead or dying stem. |

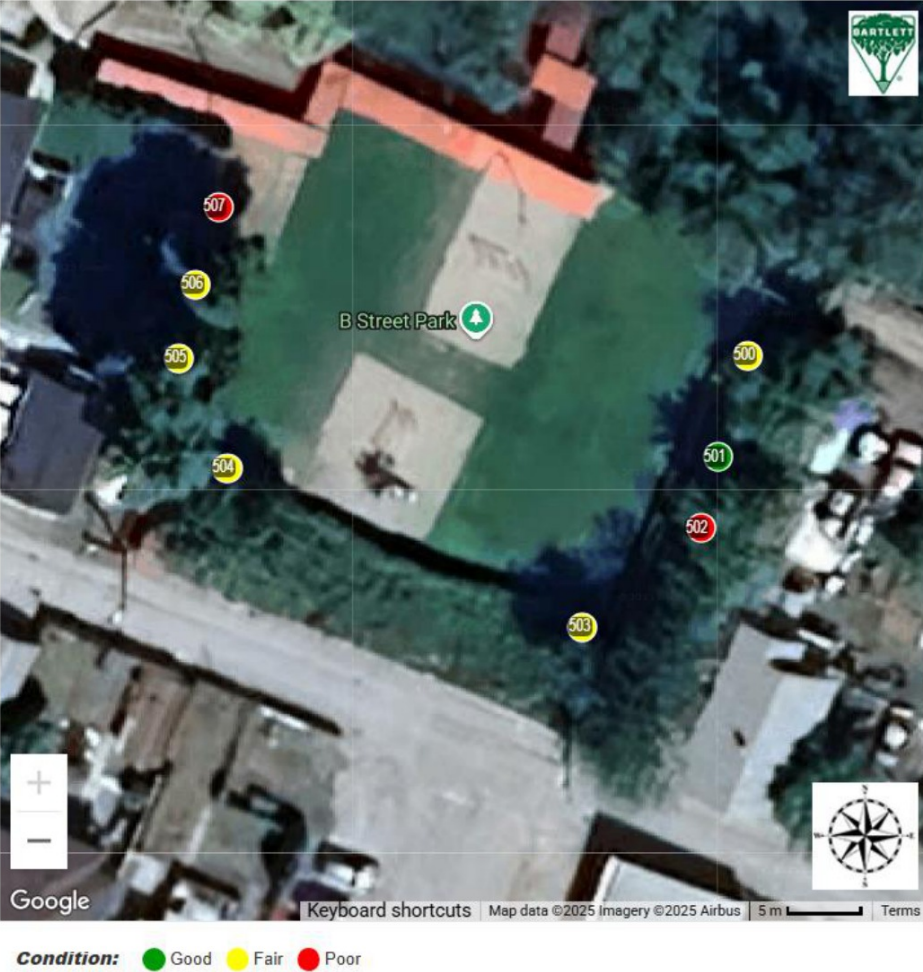
"B" Street Park  
INVENTORIED TREES BY CONDITION CLASS

| ID | Action | Species / DBH | Risk | Target | Notes |
|---|---|---|---|---|---|
| 502 | REMOVE | Mountain Ash<br>DBH: 39 cm | Moderate<br>Poor | Building | Stem cavity and dead or dying stem. |

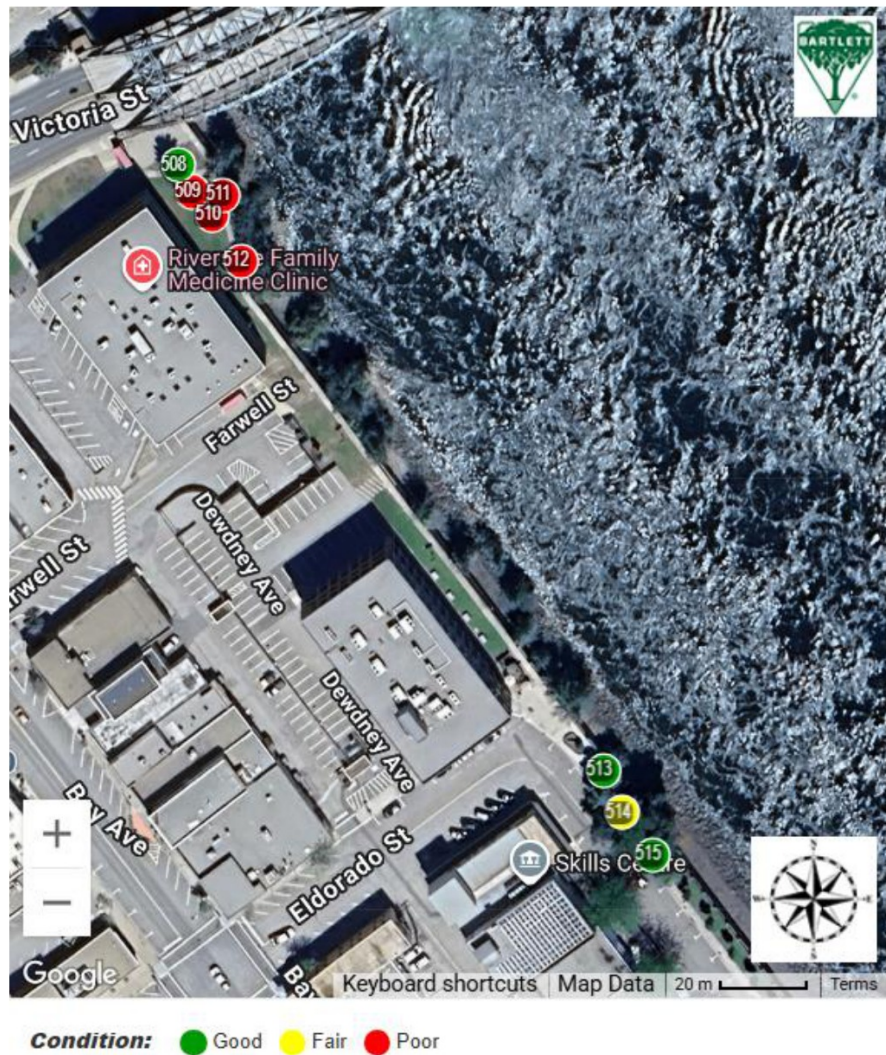
Jubilee Park & Esplanade (north)  
INVENTORIED TREES BY CONDITION CLASS

| ID | Action | Species / DBH | Risk | Target | Notes |
|---|---|---|---|---|---|
| 511 | REMOVE | Poplar-Balsam<br>DBH: 50 cm | Low<br>Poor | Path | Stem decay and moderate dieback. |
| 512 | REMOVE | Poplar-Balsam<br>DBH: 68 cm | Low<br>Poor | Path | Root-flare and stem decay. |

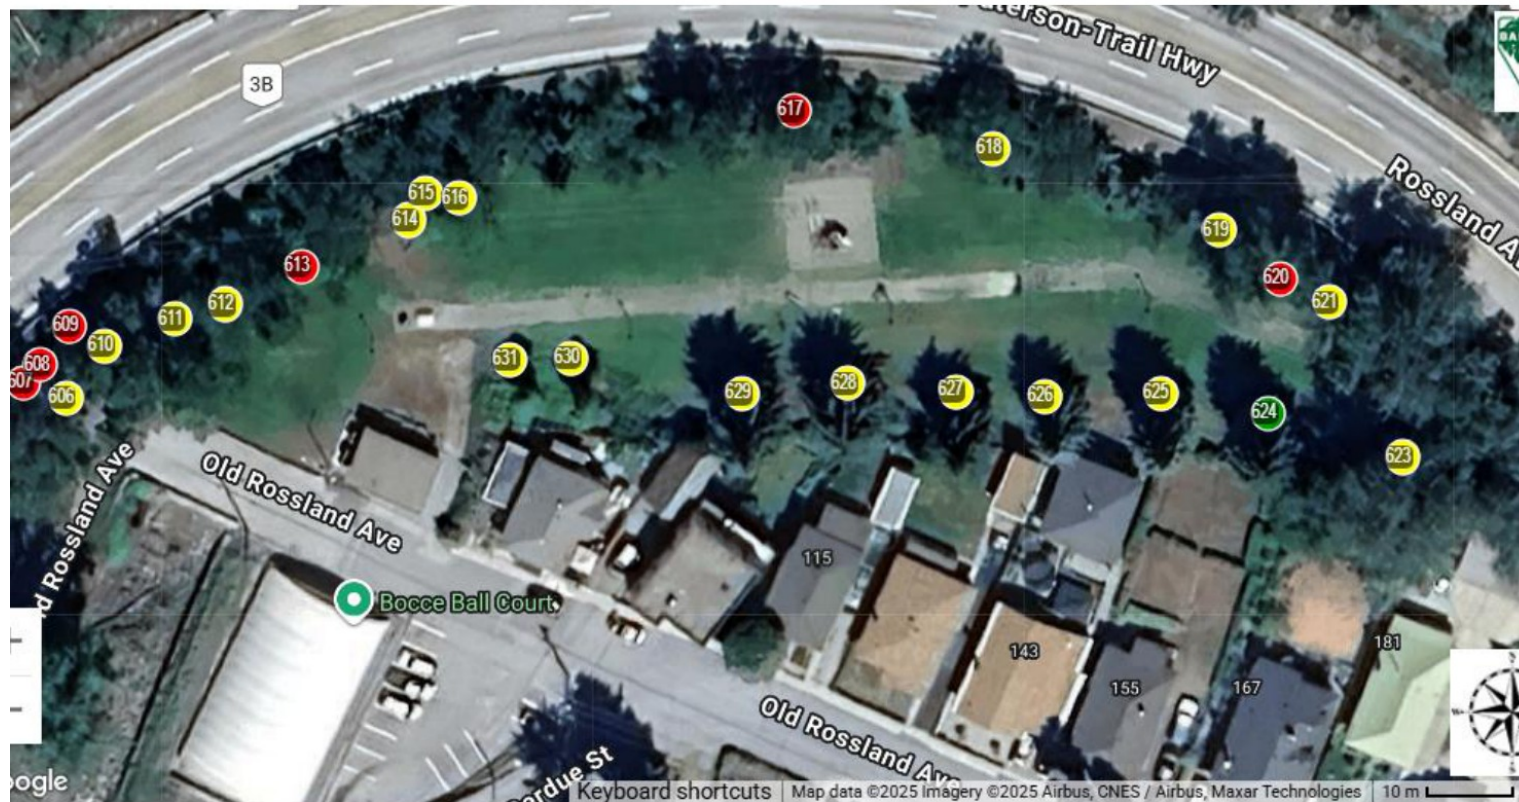
## Rossland Avenue Park INVENTORIED TREES BY CONDITION CLASS

| ID | Action | Species / DBH | Risk | Target | Notes |
|---|---|---|---|---|---|
| 617 | REMOVE | Black Locust<br>DBH: 60,56 cm | Moderate<br>Poor | Street | Root-flare cavity, stem crack and fungi/conks. |
| 622 | REMOVE | Black Locust<br>DBH: 44,38 cm | Moderate<br>Poor | Street | Dead or dying stem and severe dieback. |
